**3435, 3445, 3455 Geary Street
Joe Cassidy
An Inquiry into Construction Defects**

We reviewed the property at 3435-55 Geary Street, in San Francisco. The visual defects and flaws—such as cracking stucco, excessive caulking and deteriorating finishes—may indicate that more serious issues are concealed behind the finishes. These issues are visually unappealing and could create more damage in the future. They might also be a sign of structural defects that could put the lives of the residents at risk.

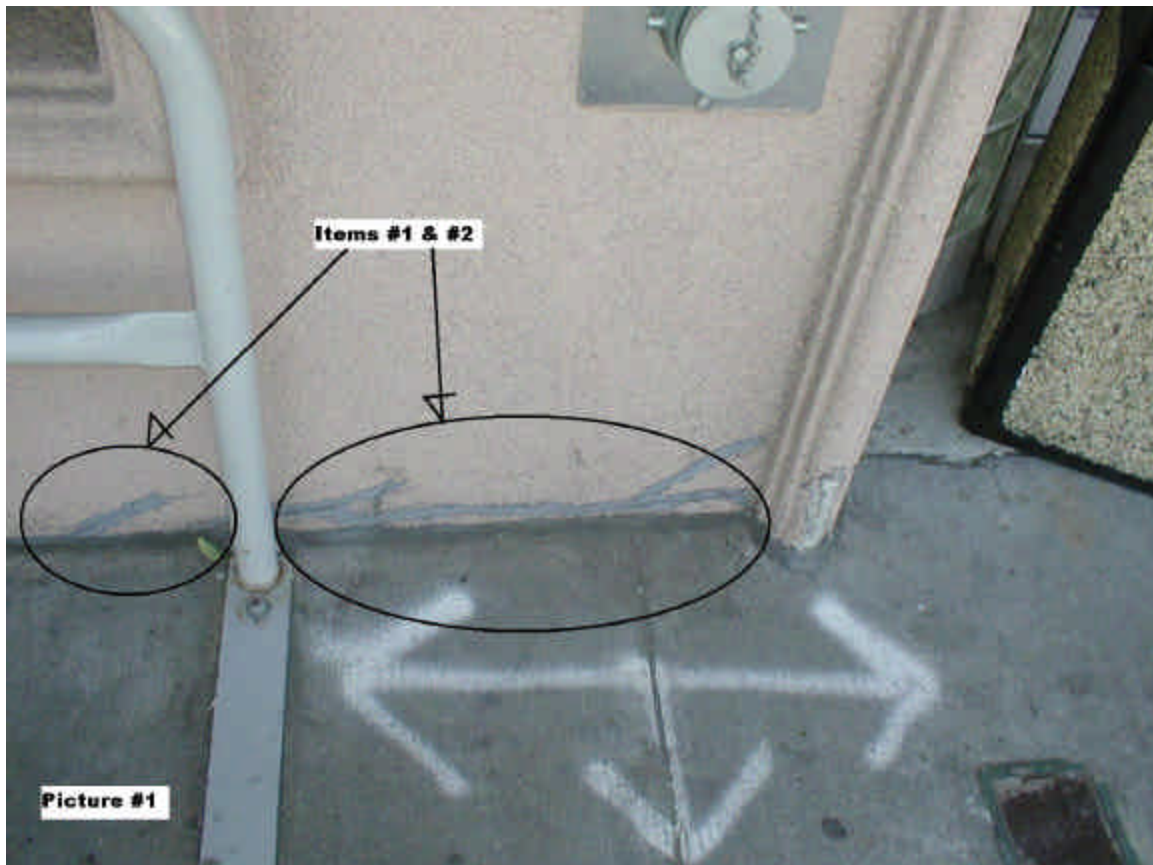
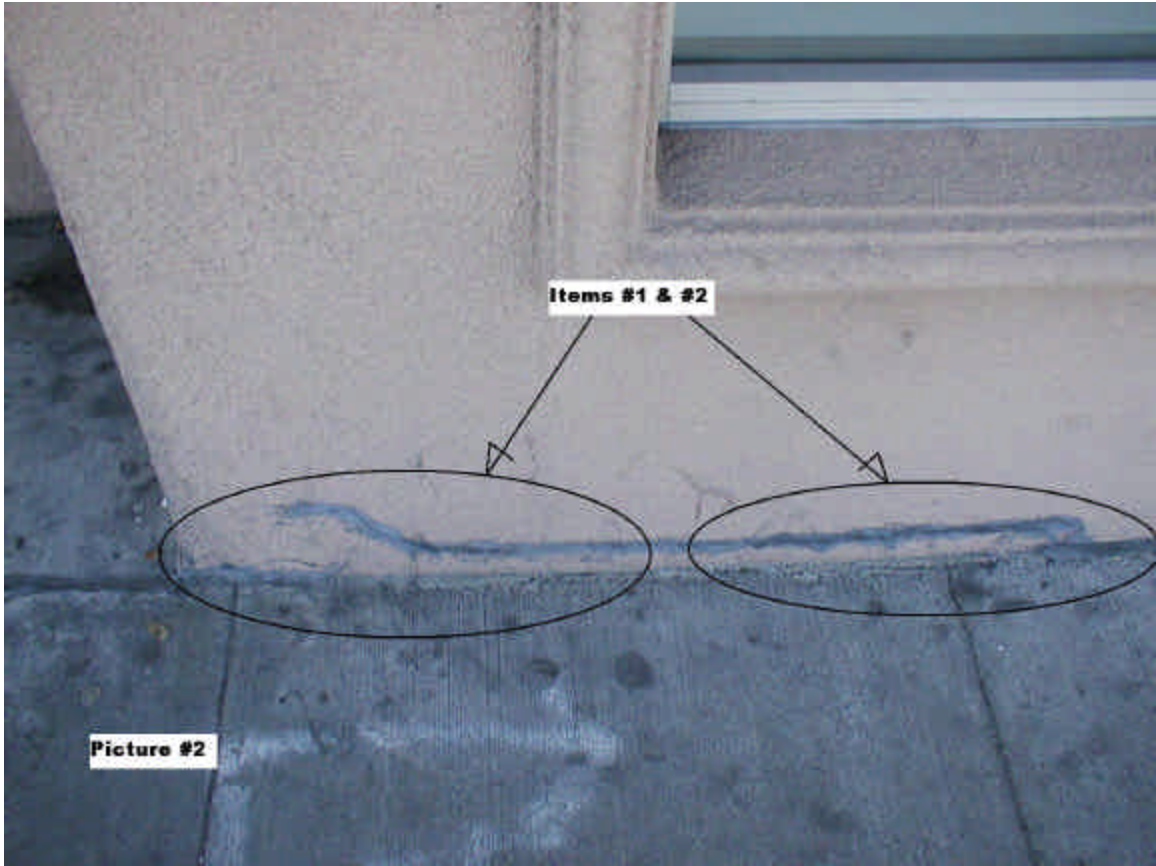
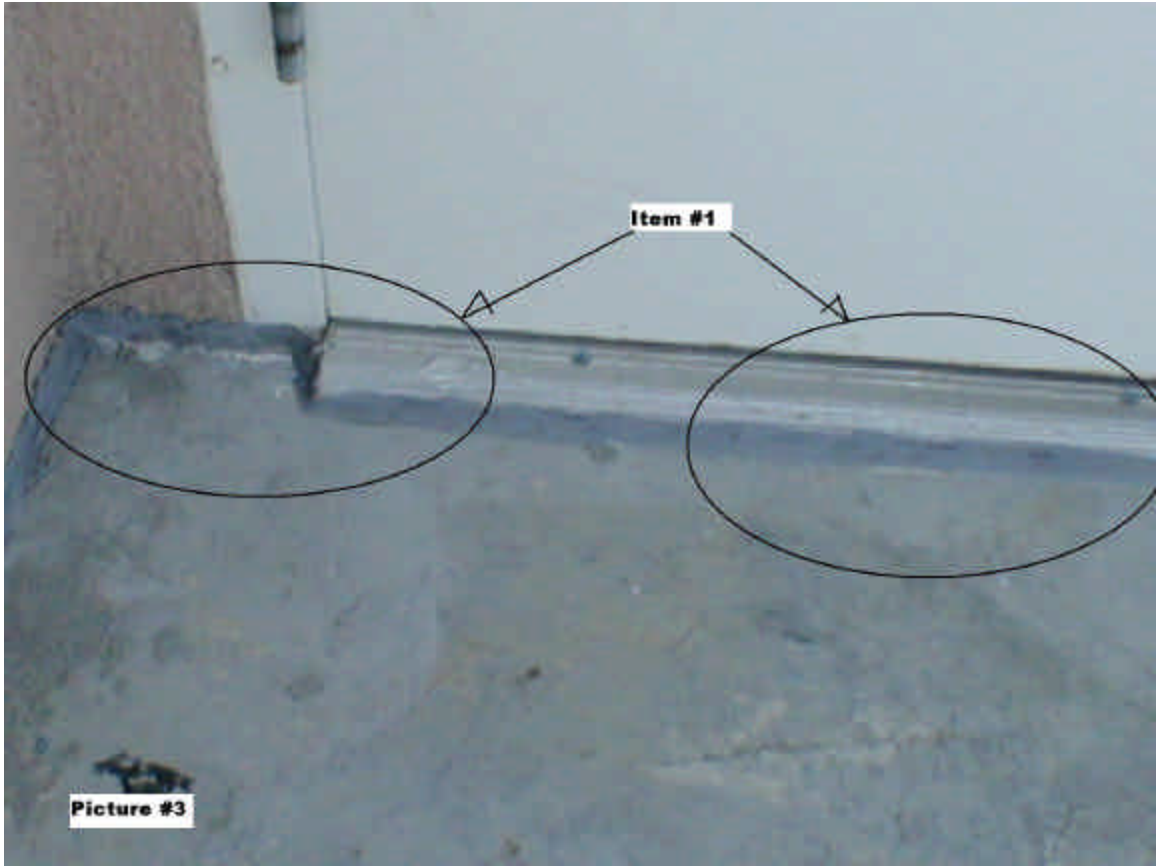
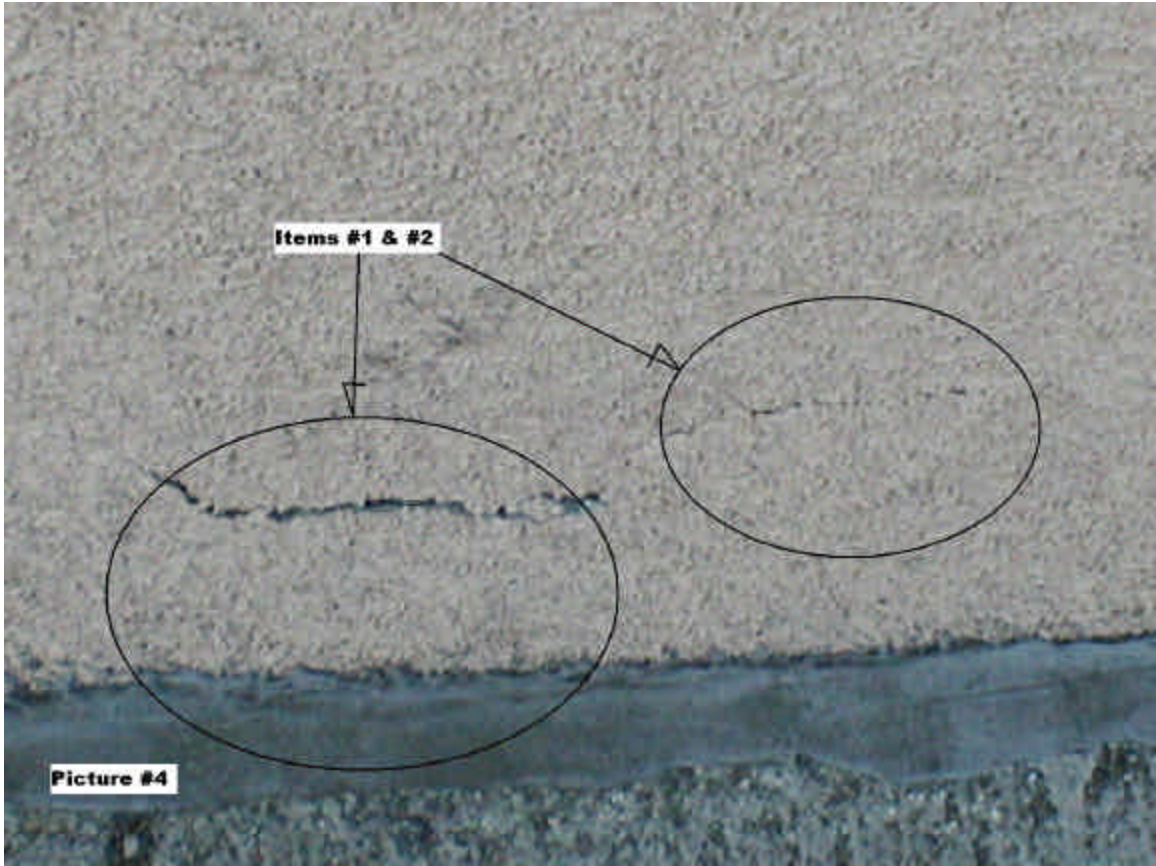
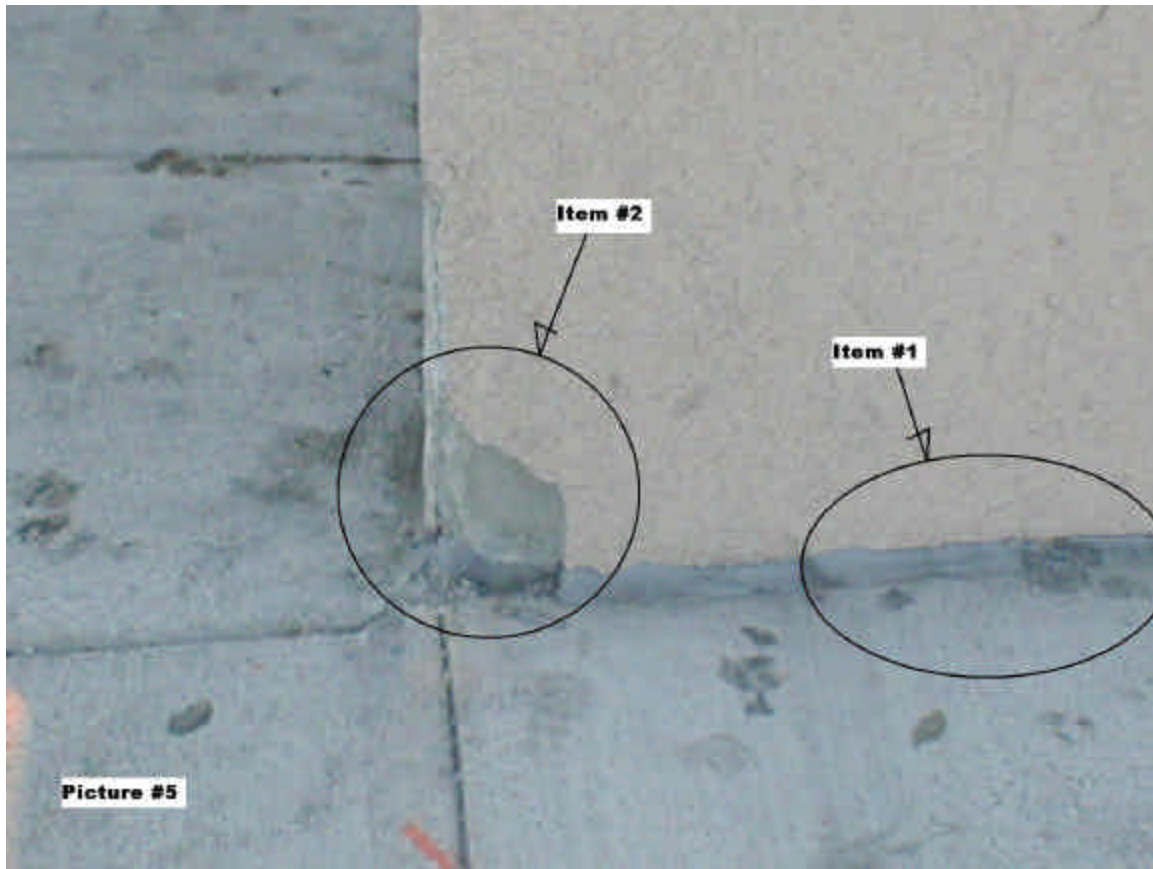
1. **CRACKING STUCCO, CAULKING (Pictures #1-#5):** Around the entire structure the stucco is cracking and falling apart. It is clear that there are issues with water being introduced to the structure by the excessive amounts of caulking that has been applied. Caulking is only a temporary fix for the more serious problem. The caulking will deteriorate with time, leaving the structure vulnerable to leaks again. Moist walls are a breeding ground for various harmful forms of mold that could affect the health of the occupants.

2. **STUCCO INSTALLATION (Pictures #1-#5):** In pictures #1-#5 it is also clear there is a warranty issue with the installation of the stucco. The cracking around the base of the structure could be a result of the contractor not following normal industry practice when installing the lathing/stucco on the building. The contractor installed the stucco too close to the ground, then placed the concrete sidewalks against the wall finish. The sidewalk expands and contracts with the weather, causing pressure against the stucco, creating these cracks. The cracking on the exterior of the building will continue as long as these conditions remain. Normal industry practice is to terminate

the stucco approximately 1-1/2" above the sidewalk. The sidewalk would then be separated from the building foundation by using an expansion material. The joint between the foundation and the sidewalk above the expansion material would then be sealed with caulking.

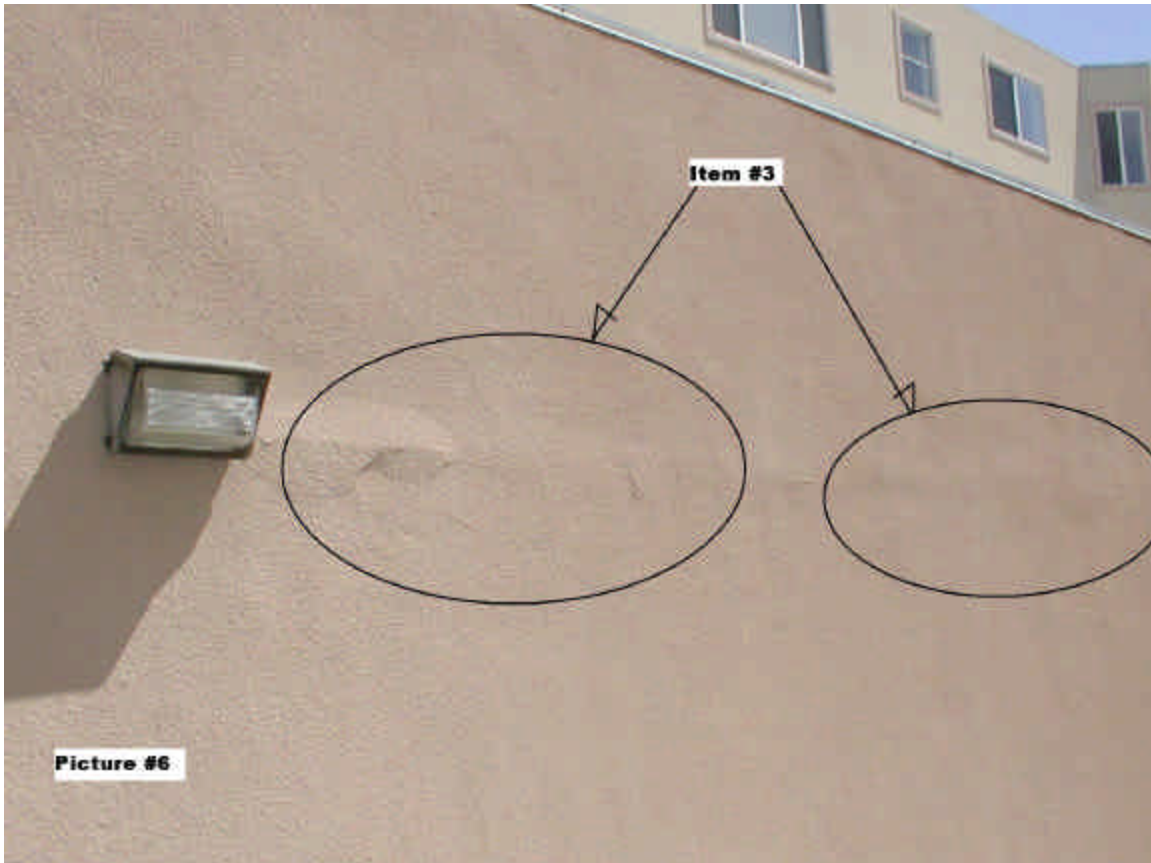
- 3. HORIZONTAL CRACKING (Picture #6):** In picture #6 there appears to be a more serious problem. The visible horizontal cracking could indicate an improper structural connection. From outside appearances it looks like the parapet wall shown may not be firmly anchored or braced to the structure and could be moving. Residents of the area in which this parapet wall is located are potentially at serious risk.

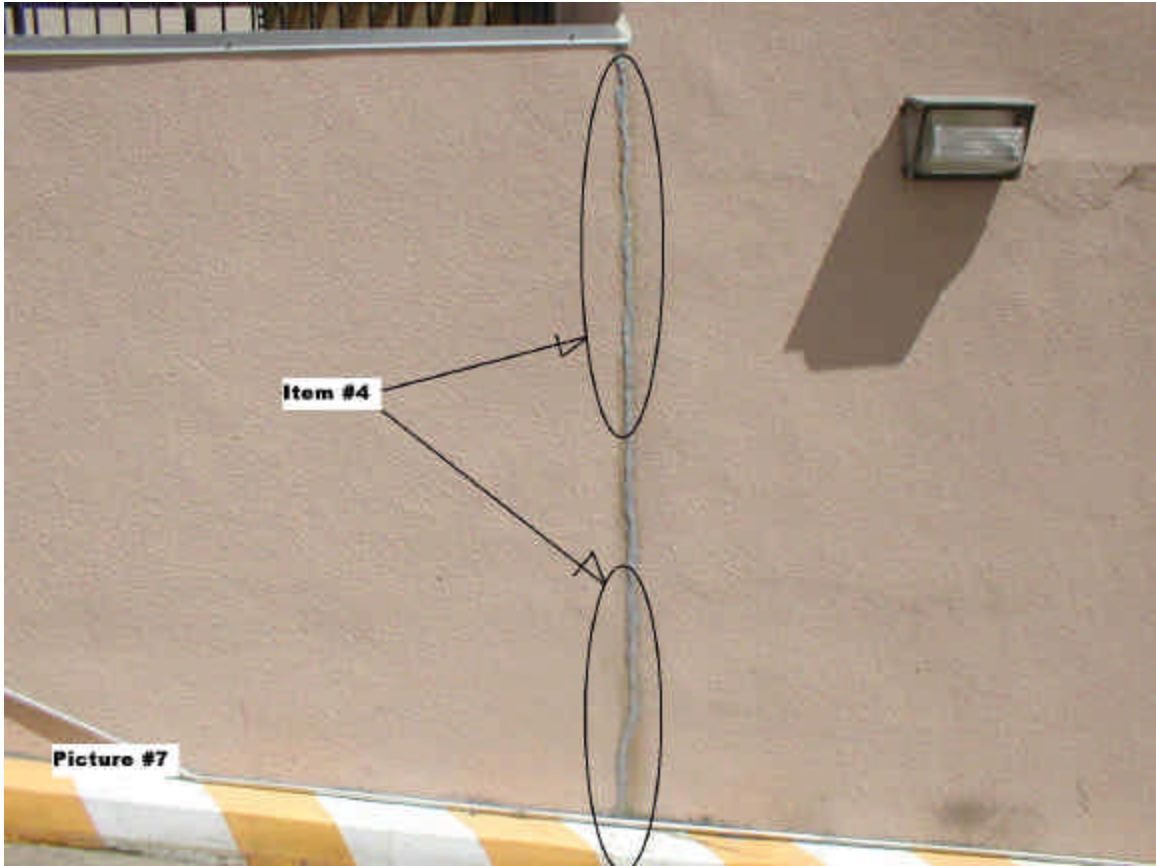
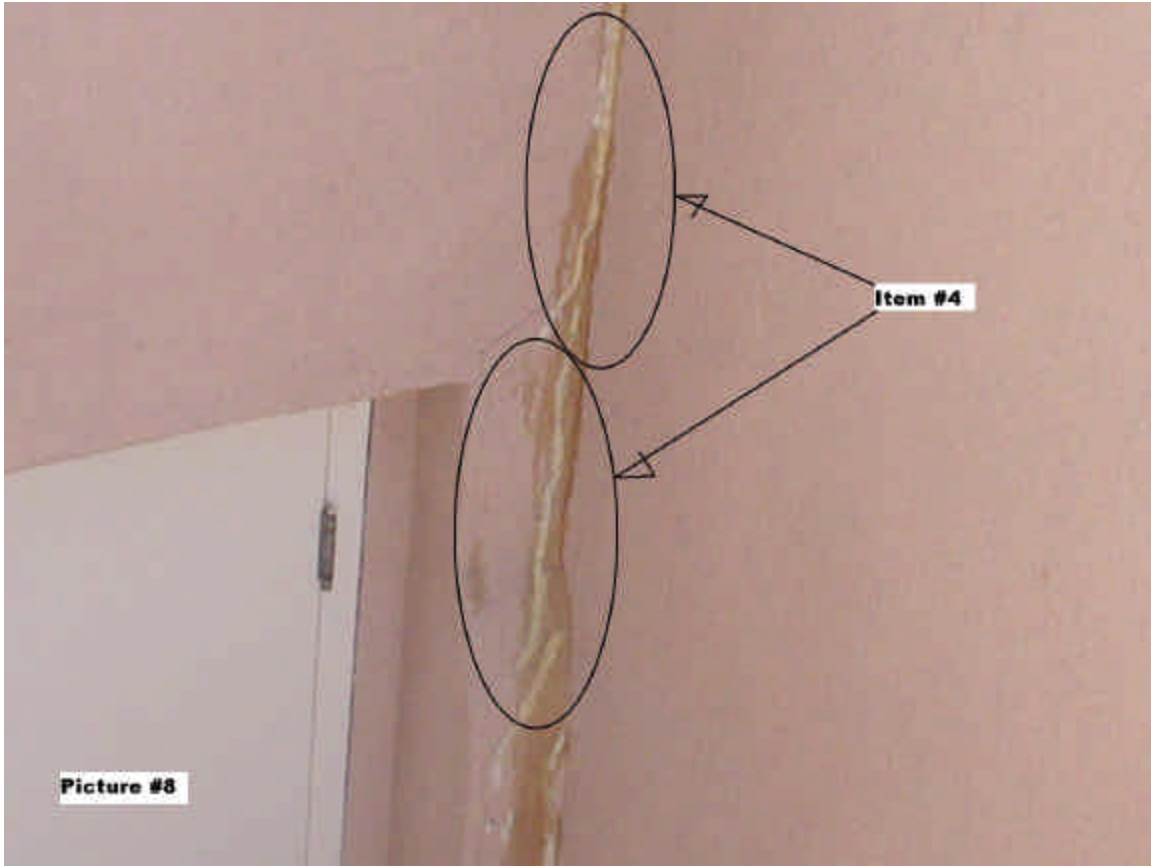
4. STUCCO CRACKS—CONTINUOUS LINE (Pictures #7-#8):
Pictures #7-#8 are other indicators that the building has potential structural defects. When the stucco cracks in a continuous line, it is sometimes an indicator that the two adjoining walls are not properly connected. This access could be utilized by the tenants as an emergency evacuation egress corridor during fire or seismic activity. The chance of failure is great if these walls are not properly secured.

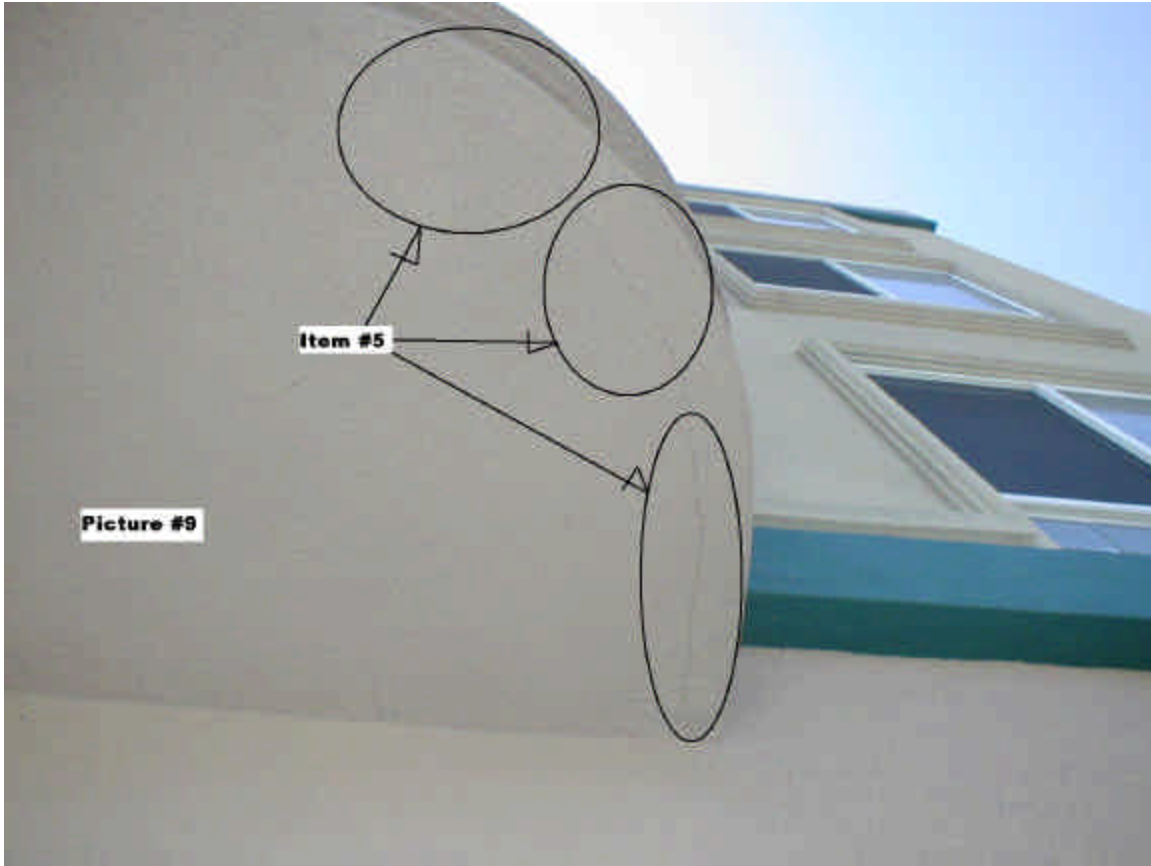
5. **BAY WINDOW—RADIUS CRACKS (Picture #9):** Picture #9 could indicate that the structural piece (the rim) that creates the radius on this bay window area is not properly secured to the joisting that creates the floor. Without reviewing the project construction drawings on file with the City of San Francisco or removing the stucco finish, it is impossible to verify the construction means utilized to create this assembly. However, the consistent radius cracking is alarming, and needs to be investigated.

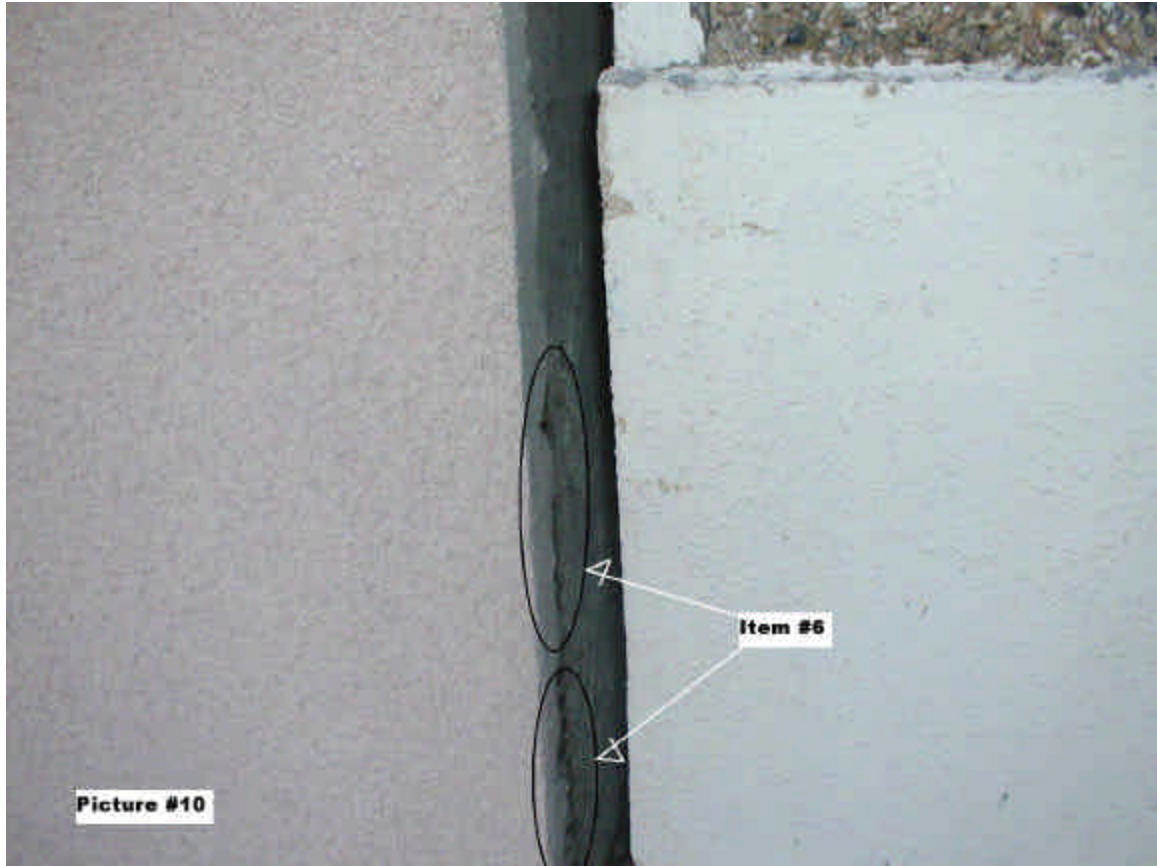
6. **STRUCTURAL REINFORCING STEEL EXPOSED TO WEATHER**
(Picture #10): Picture #10 shows the lack of attention to detail that was utilized while constructing the building. As you can see, the structural reinforcing steel was not properly covered in concrete, and is exposed to the weather. If the reinforcing steel is not properly encapsulated with concrete, the column will not have the intended design strength. Additionally, concrete reinforcing steel that is exposed to weather will corrode. The reinforcing steel is not protected, and if this steel is left in its current state, the corrosion will continue through all the reinforcing steel in this area.

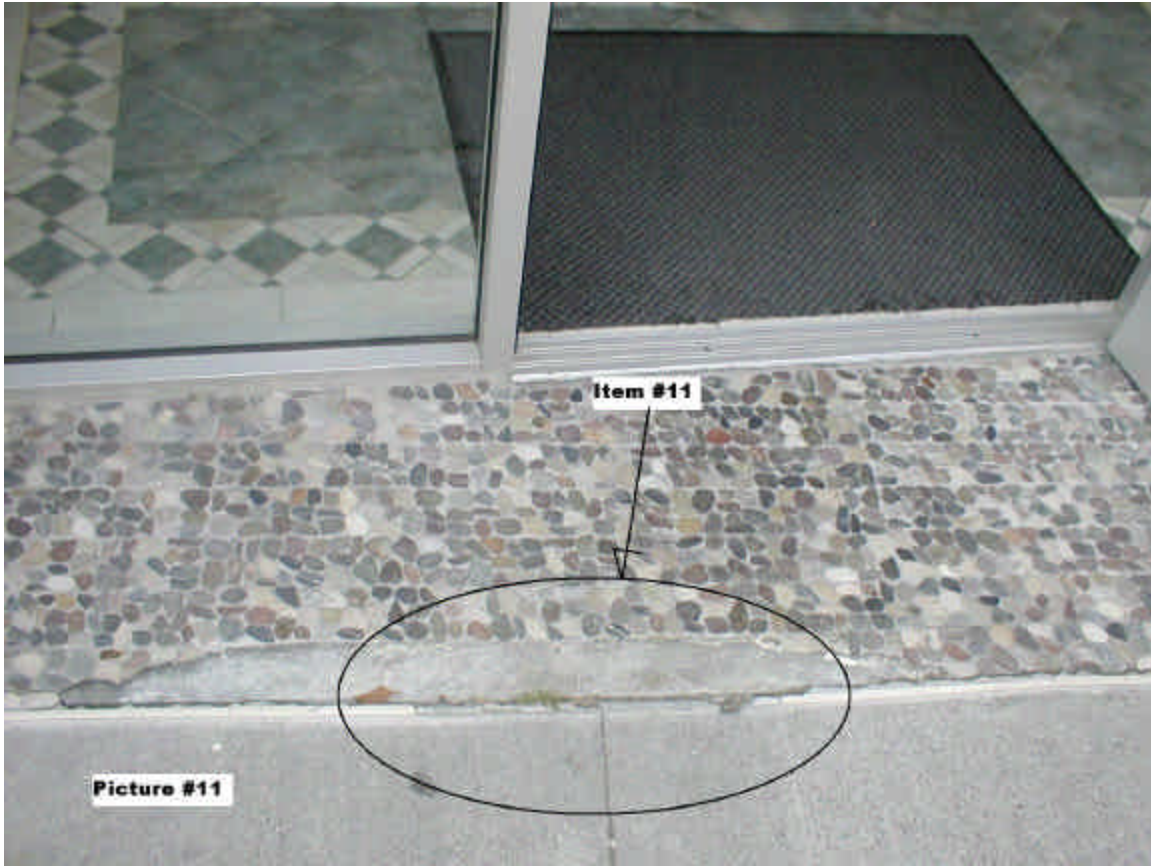
7. **TRIPPING HAZARD (Picture #11):** Picture #11 is yet another example of the contractor's quality. We are concerned for the safety of the residents. This discrepancy creates a major tripping hazard in front of the main entrance of the building.

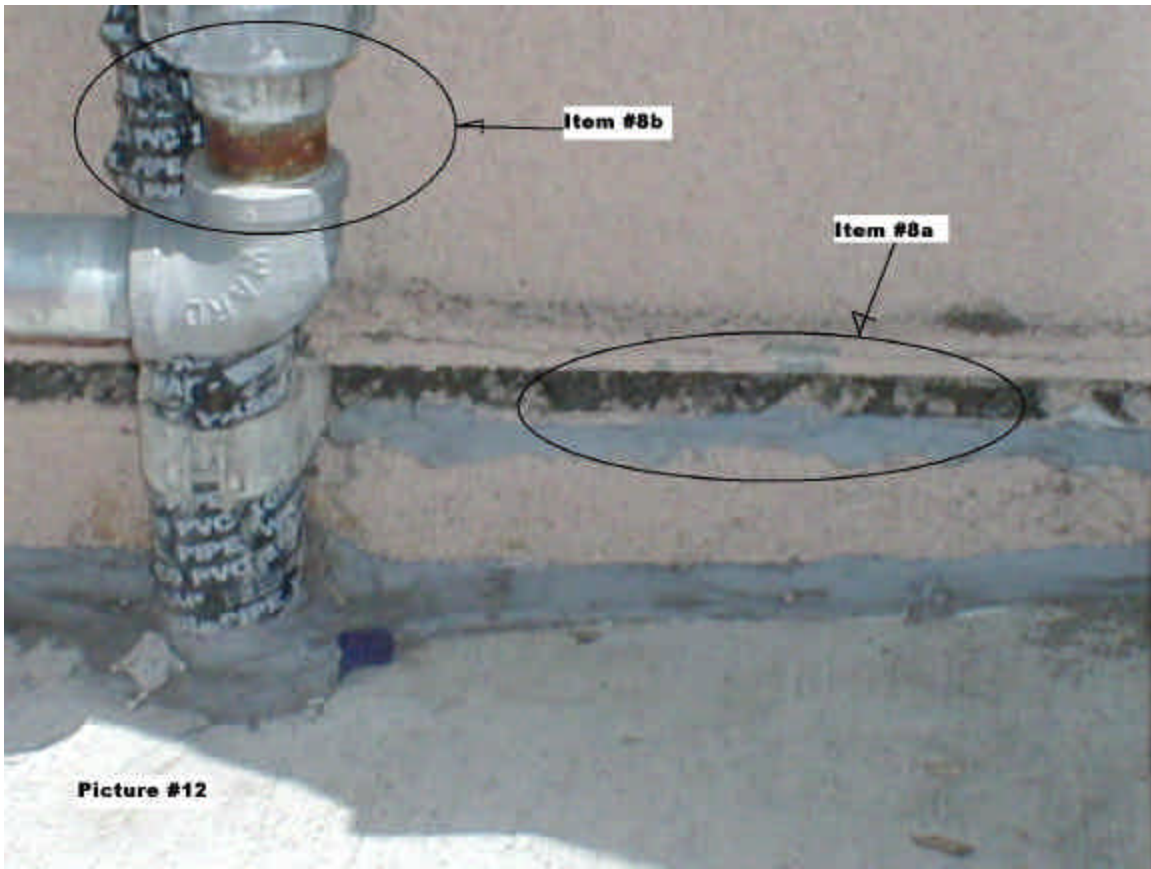
- 8. GAS METER MOUNTING (Picture #12):** Picture #12 has a couple of issues that need investigation. The “uni-strut” that was utilized to secure the gas meters and its associated piping should have been mounted over the building finish. The strut was installed to the wall, then the stucco was applied around. This is a common leak point and needs to be corrected. Another issue is that the gas meter was installed with a non-galvanized fitting. Gas piping that is exposed to the weather has to be coated to prevent corrosion, which leads to pipe failure.
