**3930 24th Street
Joe Cassidy
An Inquiry into Construction Defects**

We reviewed the property at 3930 24th Street, San Francisco. The building appears to have numerous defects, which may indicate that more serious issues are concealed behind finishes. These defects include cracking stucco and deteriorating finishes. These issues are visually unappealing, and could create more damage in the future. They might also be a sign of structural defects that could put the lives of the residents at risk.

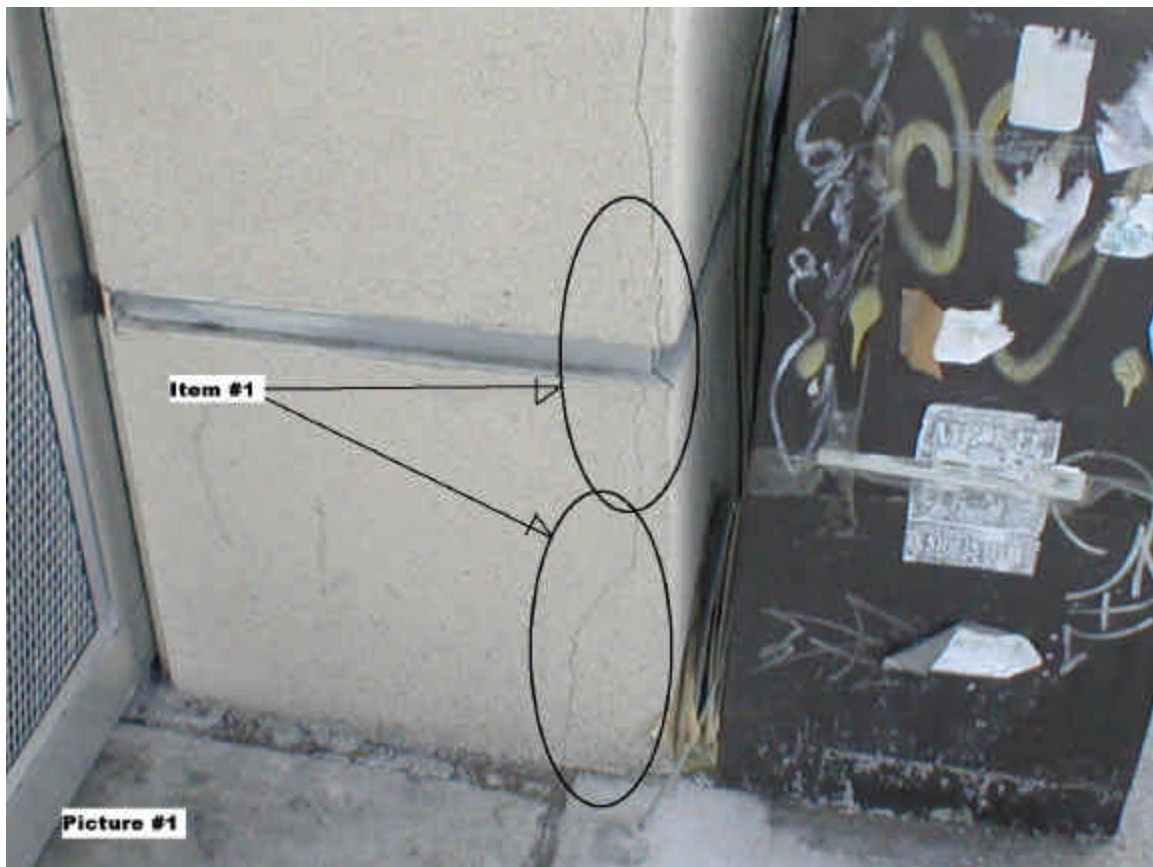
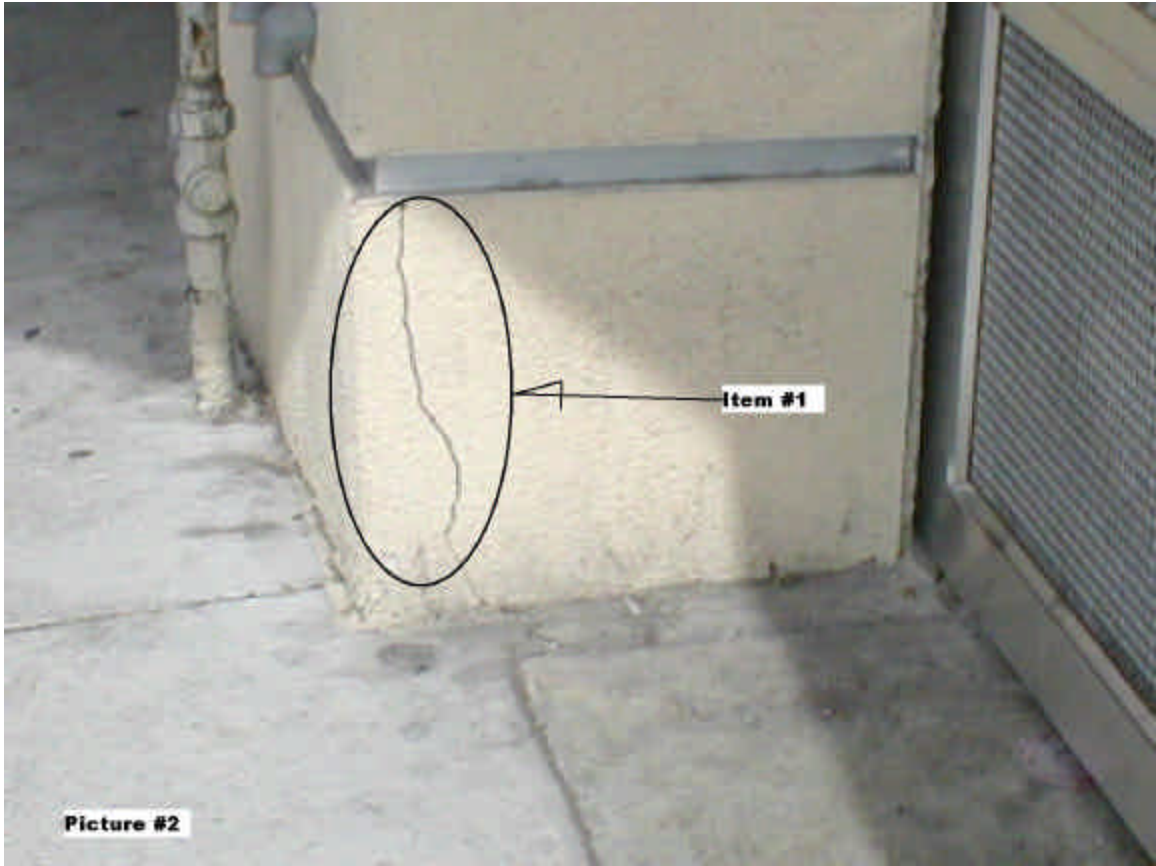
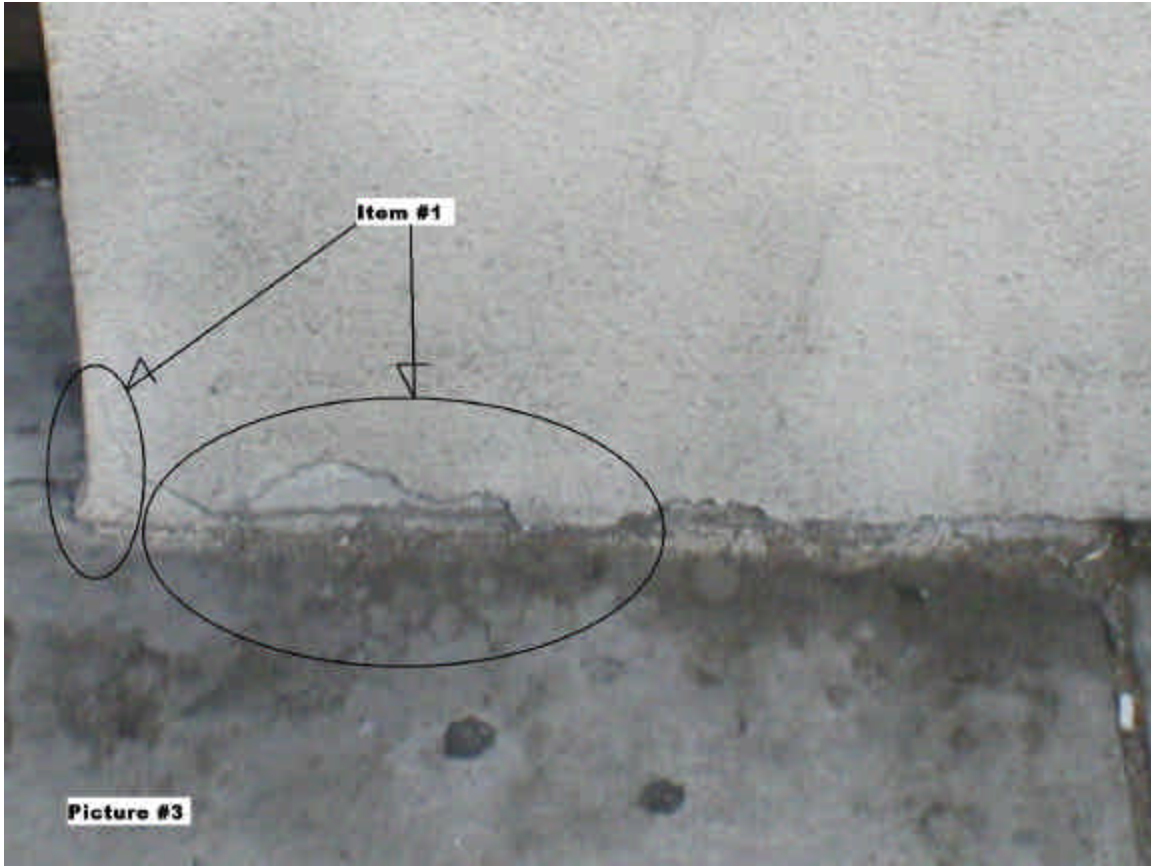
- 1. CRACKING STUCCO AT BASE OF BUILDING (Pictures #1-#3):**
The stucco is cracking and falling apart around the entire base of the structure. It is clear there is a warranty issue with the installation of the stucco. The contractor did not follow normal industry practices when installing the lathing/stucco on the building, resulting in consistent cracking around the base of the structure. The contractor installed the stucco too close to the ground, then placed the concrete sidewalks against the wall finish. The cracks are created when the sidewalk expands and contracts with the weather, causing pressure against the stucco. The cracking on the exterior of the building will continue as long as these conditions remain. Normal industry practice is to terminate the stucco approximately 1-1/2" above the sidewalk. An expansion material would separate the building foundation and the sidewalk. The joint between the foundation and the sidewalk above the expansion material would then be sealed with caulking. In the case of this building, the visible cracks leave the structure vulnerable to attacks from insects, fungi and water. Moist walls are a breeding ground for various harmful forms of mold that could affect the health of the occupants.

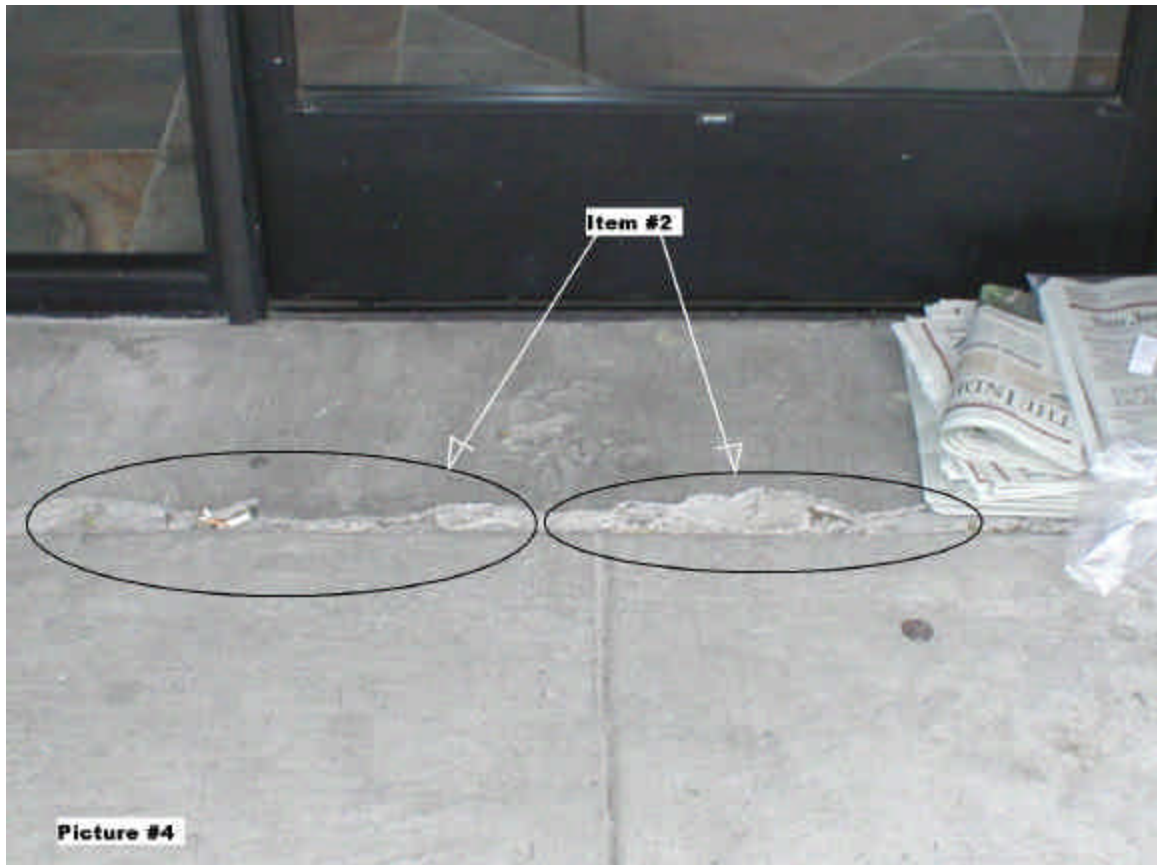
2. **TRIPPING HAZARD (Picture #4):** Picture #4 raises concern for the safety of the residents, and reflects the quality of the work of the contractors. This discrepancy creates a major tripping hazard in front of the main entrance of the building. The skimmed concrete layer that was installed on top of the original sidewalk is deteriorating and falling apart, creating the hazard.

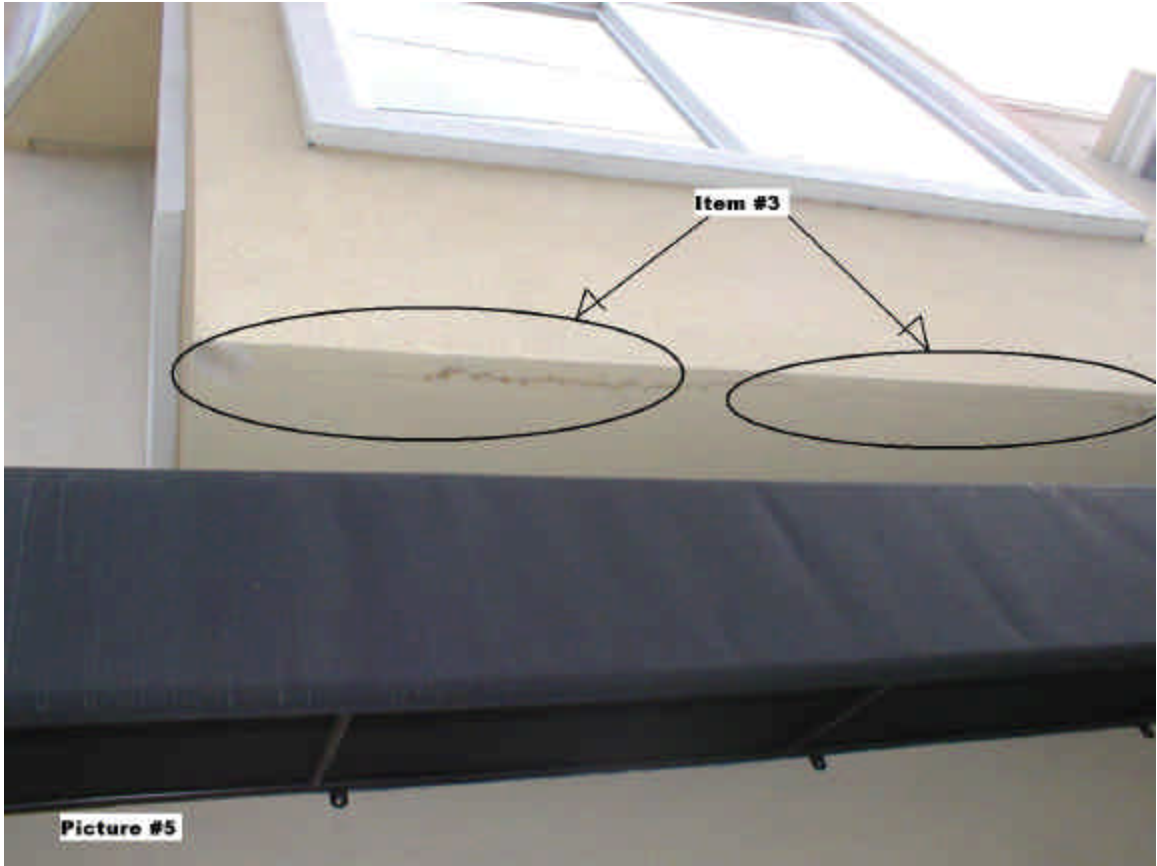
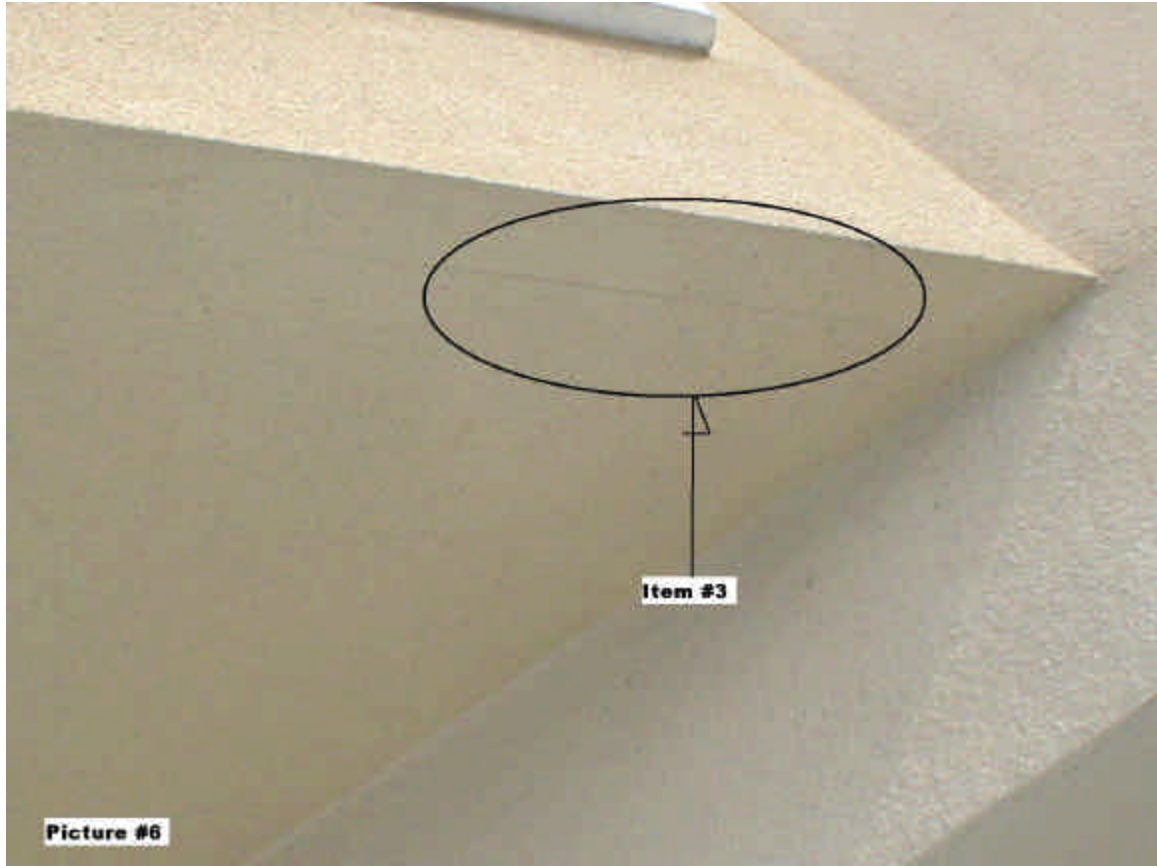
3. **STUCCO CRACKS IN A CONTINUOUS LINE (Pictures #5-#6):**
The cracking in pictures #5 & #6 may indicate that the building has potential structural defects. When stucco cracks in a continuous line, it suggests that two structural members may be acting against each other. The structural members should be mechanically connected using various methods that would be detailed on the project plans. The locations and patterns of stucco cracking raise questions. These conditions need further investigation.

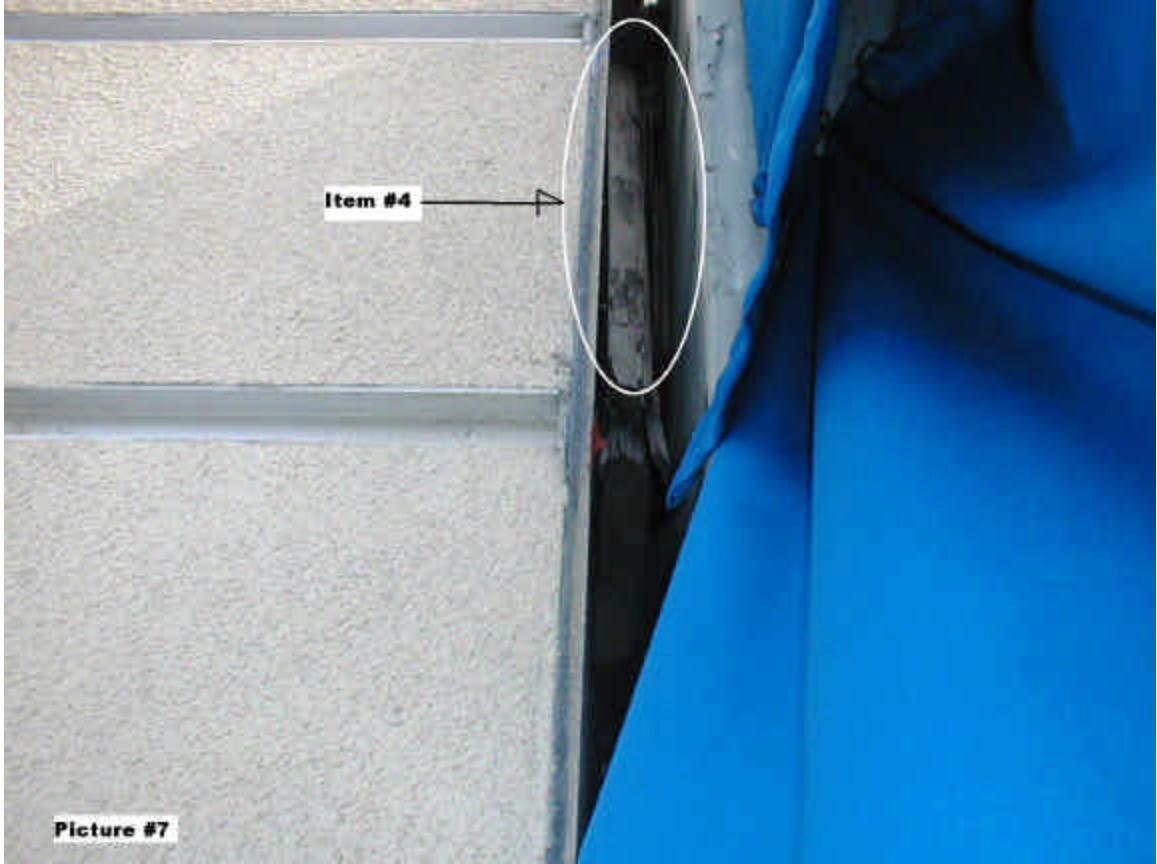
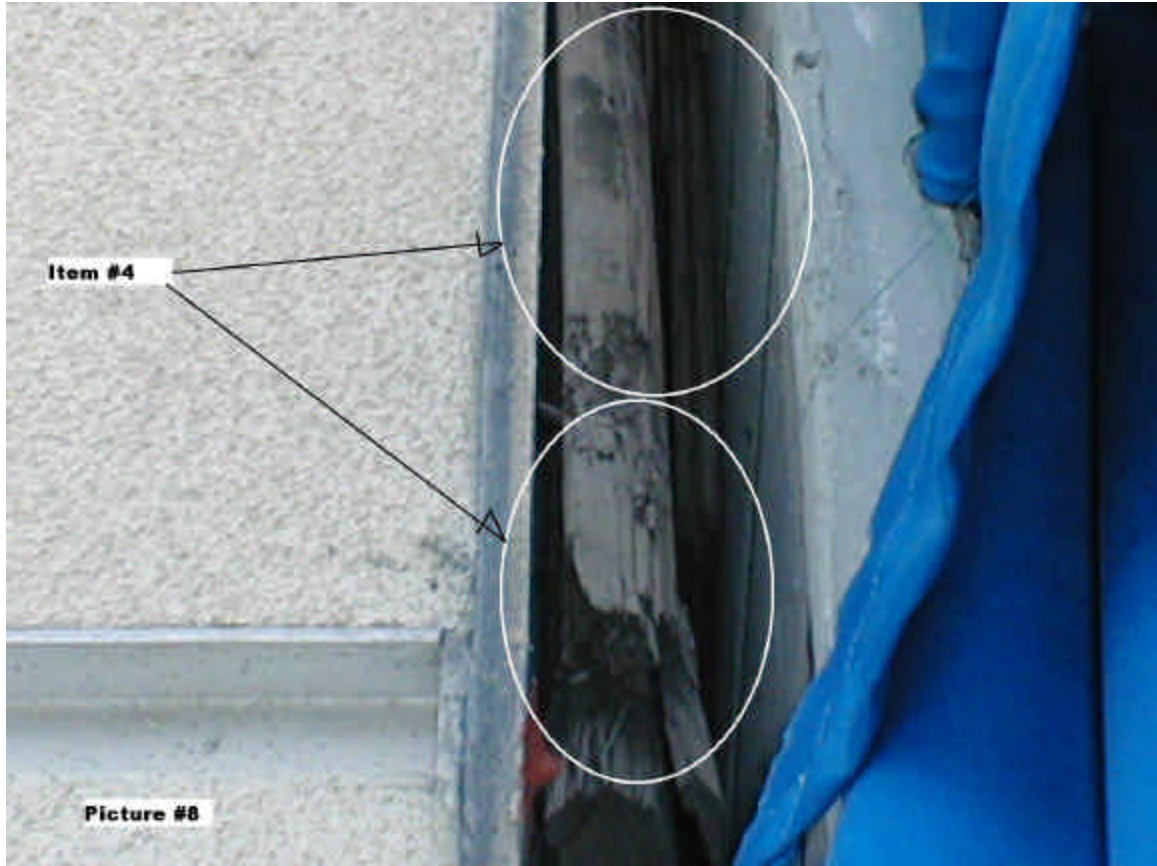
4. **POSSIBLE FIRE HAZARD (Pictures #7 & #8):** Pictures #7 & #8 show the fire wall/expansion area between the building and the structure along side. This area is to be clear and free of combustible materials. The contractor has left masonry/concrete forming materials between the buildings, which could provide an ignition point for fire. Additionally, the expansion area is provided so the two structures can act independently. This material creates a rigid condition and the two structures could suffer damage, especially during seismic activity.

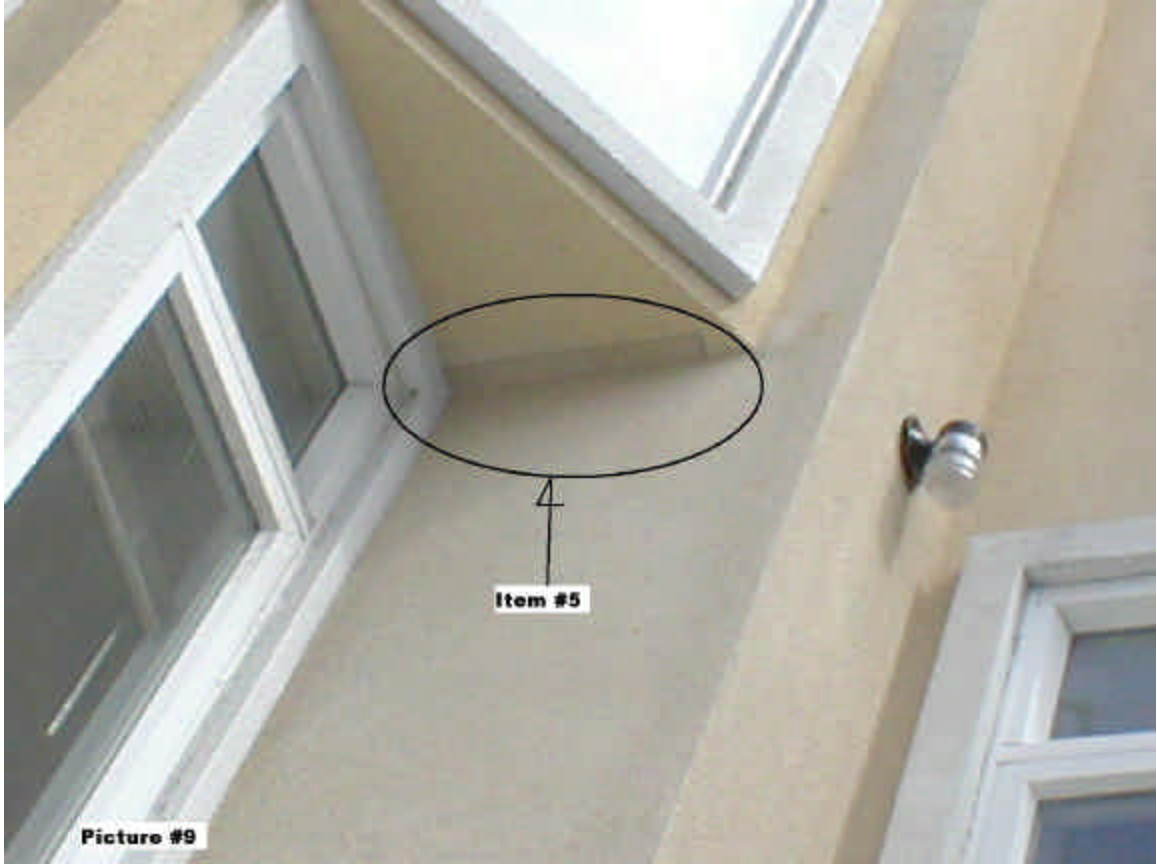
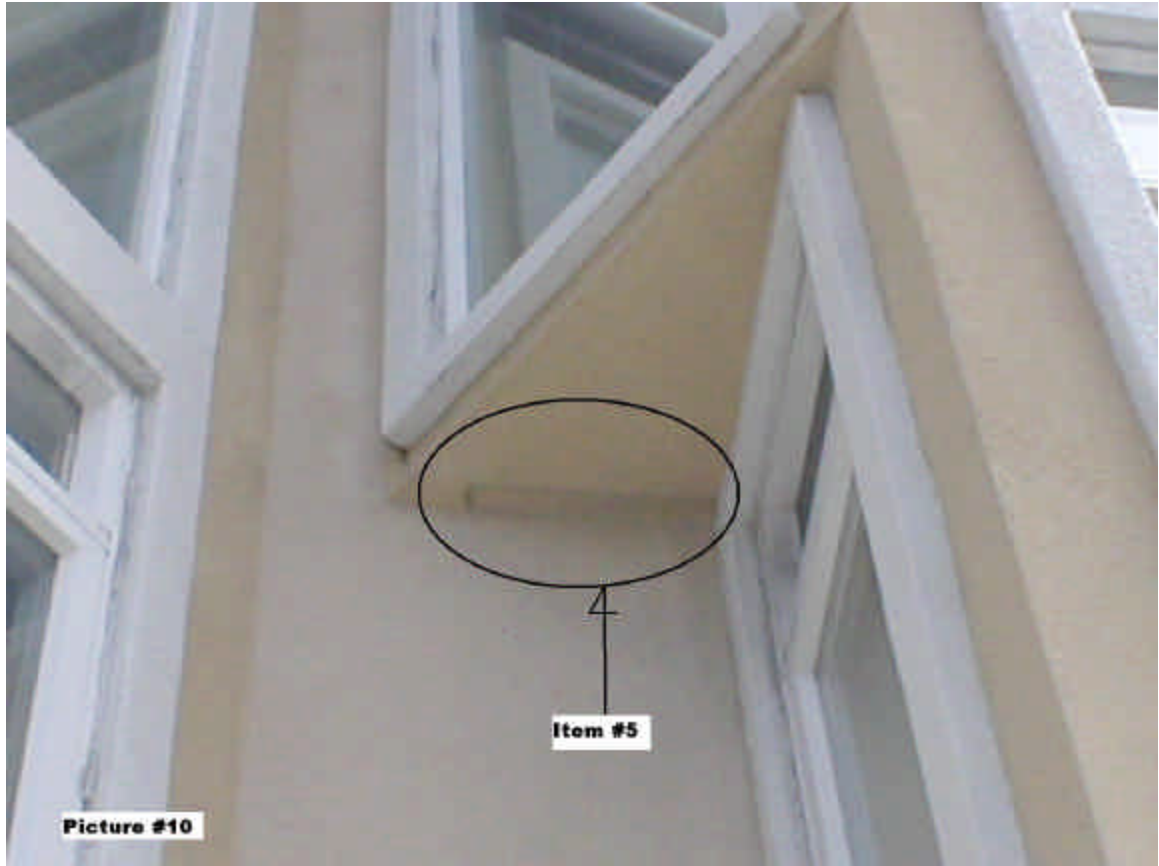
5. **BLOCKED AIR VENTS (Pictures #9 & #10):** Pictures #9 & #10 are examples of the attention to detail with which the building was constructed. The vents are almost completely blocked by over-spray. These vents are traditionally installed to allow the structure to breathe. Air flow is normally provided into areas of the structure where wood is encapsulated, preventing dry rot.
